AD376028

WGC-RESEARCH AND DEVELOPMENT REPORT

Physical Characteristics of Air Blast (Section I) - - - -	3
Effects on Superstructures (Section II) - - - - -	7
Conclusions and Recommendations (Section III) - - - -	20
Photographic Section (Section IV) - - - - -	28

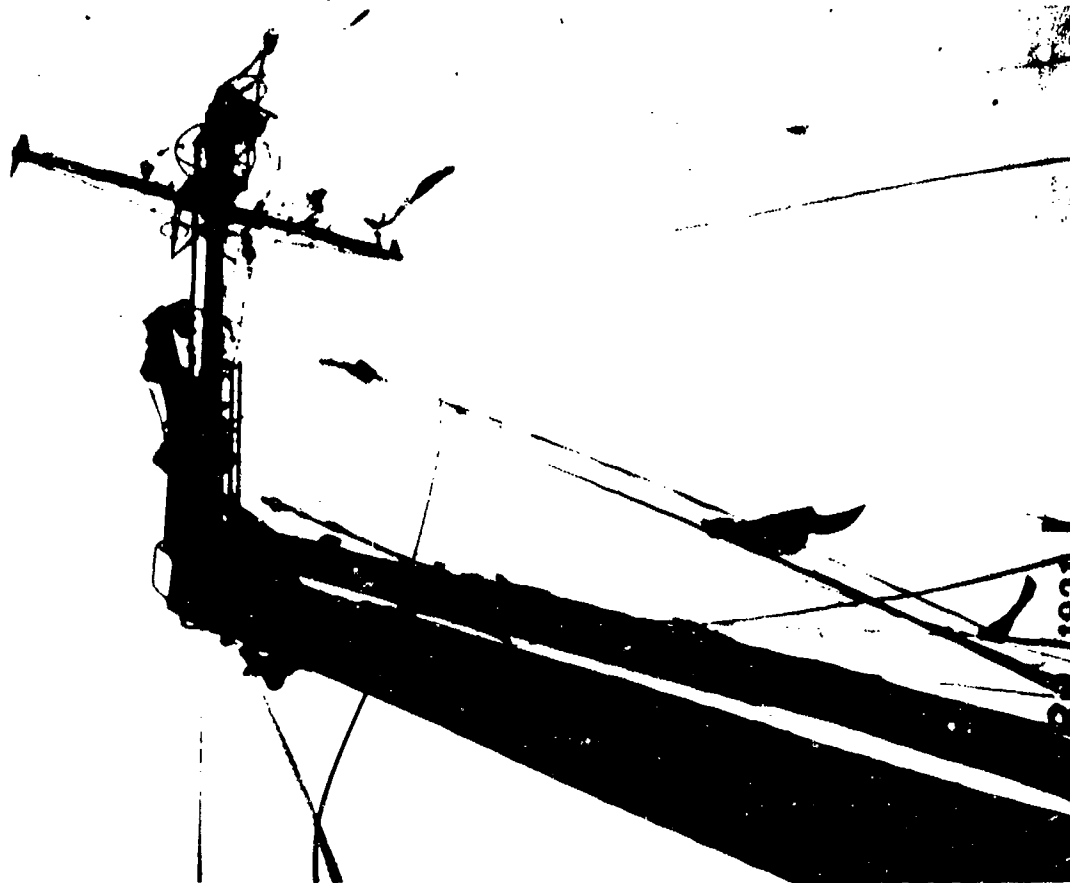
1. Masts and Spars. A detailed study of the behavior of masts and spars is the subject of a separate report. It appears that serious damage to masts and spars extended out to 800 yards on heavy ships and to 1100 yards on light vessels. Sporadic minor deflections occur in ships further removed. In Test A, four vessels were located about 600 yards (horizontal distance) from the burst. These were INDEPENDENCE (CVL22), NEVADA (BB36), ARKANSAS (BB33) and CRITTENDEN (APA77). The peak pressure experienced at this range was about 34 pounds per square inch and the wind velocity in the wave was momentarily about 700 miles per hour. INDEPENDENCE (CVL22) took the air blast over the port quarter. The cage-type mast structure supporting fire control equipment and radar is completely missing from the upper level of the island as shown in Photo 2040-6, page 27. Photo 196-151-23, page 28 shows the mast structure before test. NEVADA (BB36) also received the blast from the port quarter. The effect on topmasts is shown in Photo 1832-9, page 29. The masts and radar antennae all failed at discontinuities. A close-up view of the main topmast, Photo 1897-10, page 30, indicates that the mast bent considerably before parting from the platform. On ARKANSAS (BB33), which received the air blast on the starboard quarter, a similar condition resulted (Photo 1774-11, page 31). The main topmast has been torn from its connection to the director platform (Photo 1775-12, page 32). On the foremast, however, the radar pole mast is still connected to the radar platform although it is bent nearly double (Photo 2097-3, page 33). Signal yardarms are all bent forward. CRITTENDEN (APA77) was bow-on to the blast. Photo 227-49-116, page 34 indicates the effect of the air blast upon the pole masts. These are bent drastically aft but have not fractured. All three masts bent sharply at discontinuities or supports. (Photos 1921-10, 1922-8, and 1806-9; pages 35, 36 and 37).

AA-CR-82-1921-10. U.S.S. CRITTENDEN (APA77). Air blast damage to fore top mast.
